PHASE II ENVIRONMENTAL SITE ASSESSMENT

Estates of Glenway, Town of Newmarket

Project No.: L09-301

**Re: Phase II Environmental Site Assessment  
470 Crossland Gate, Newmarket, Ontario**

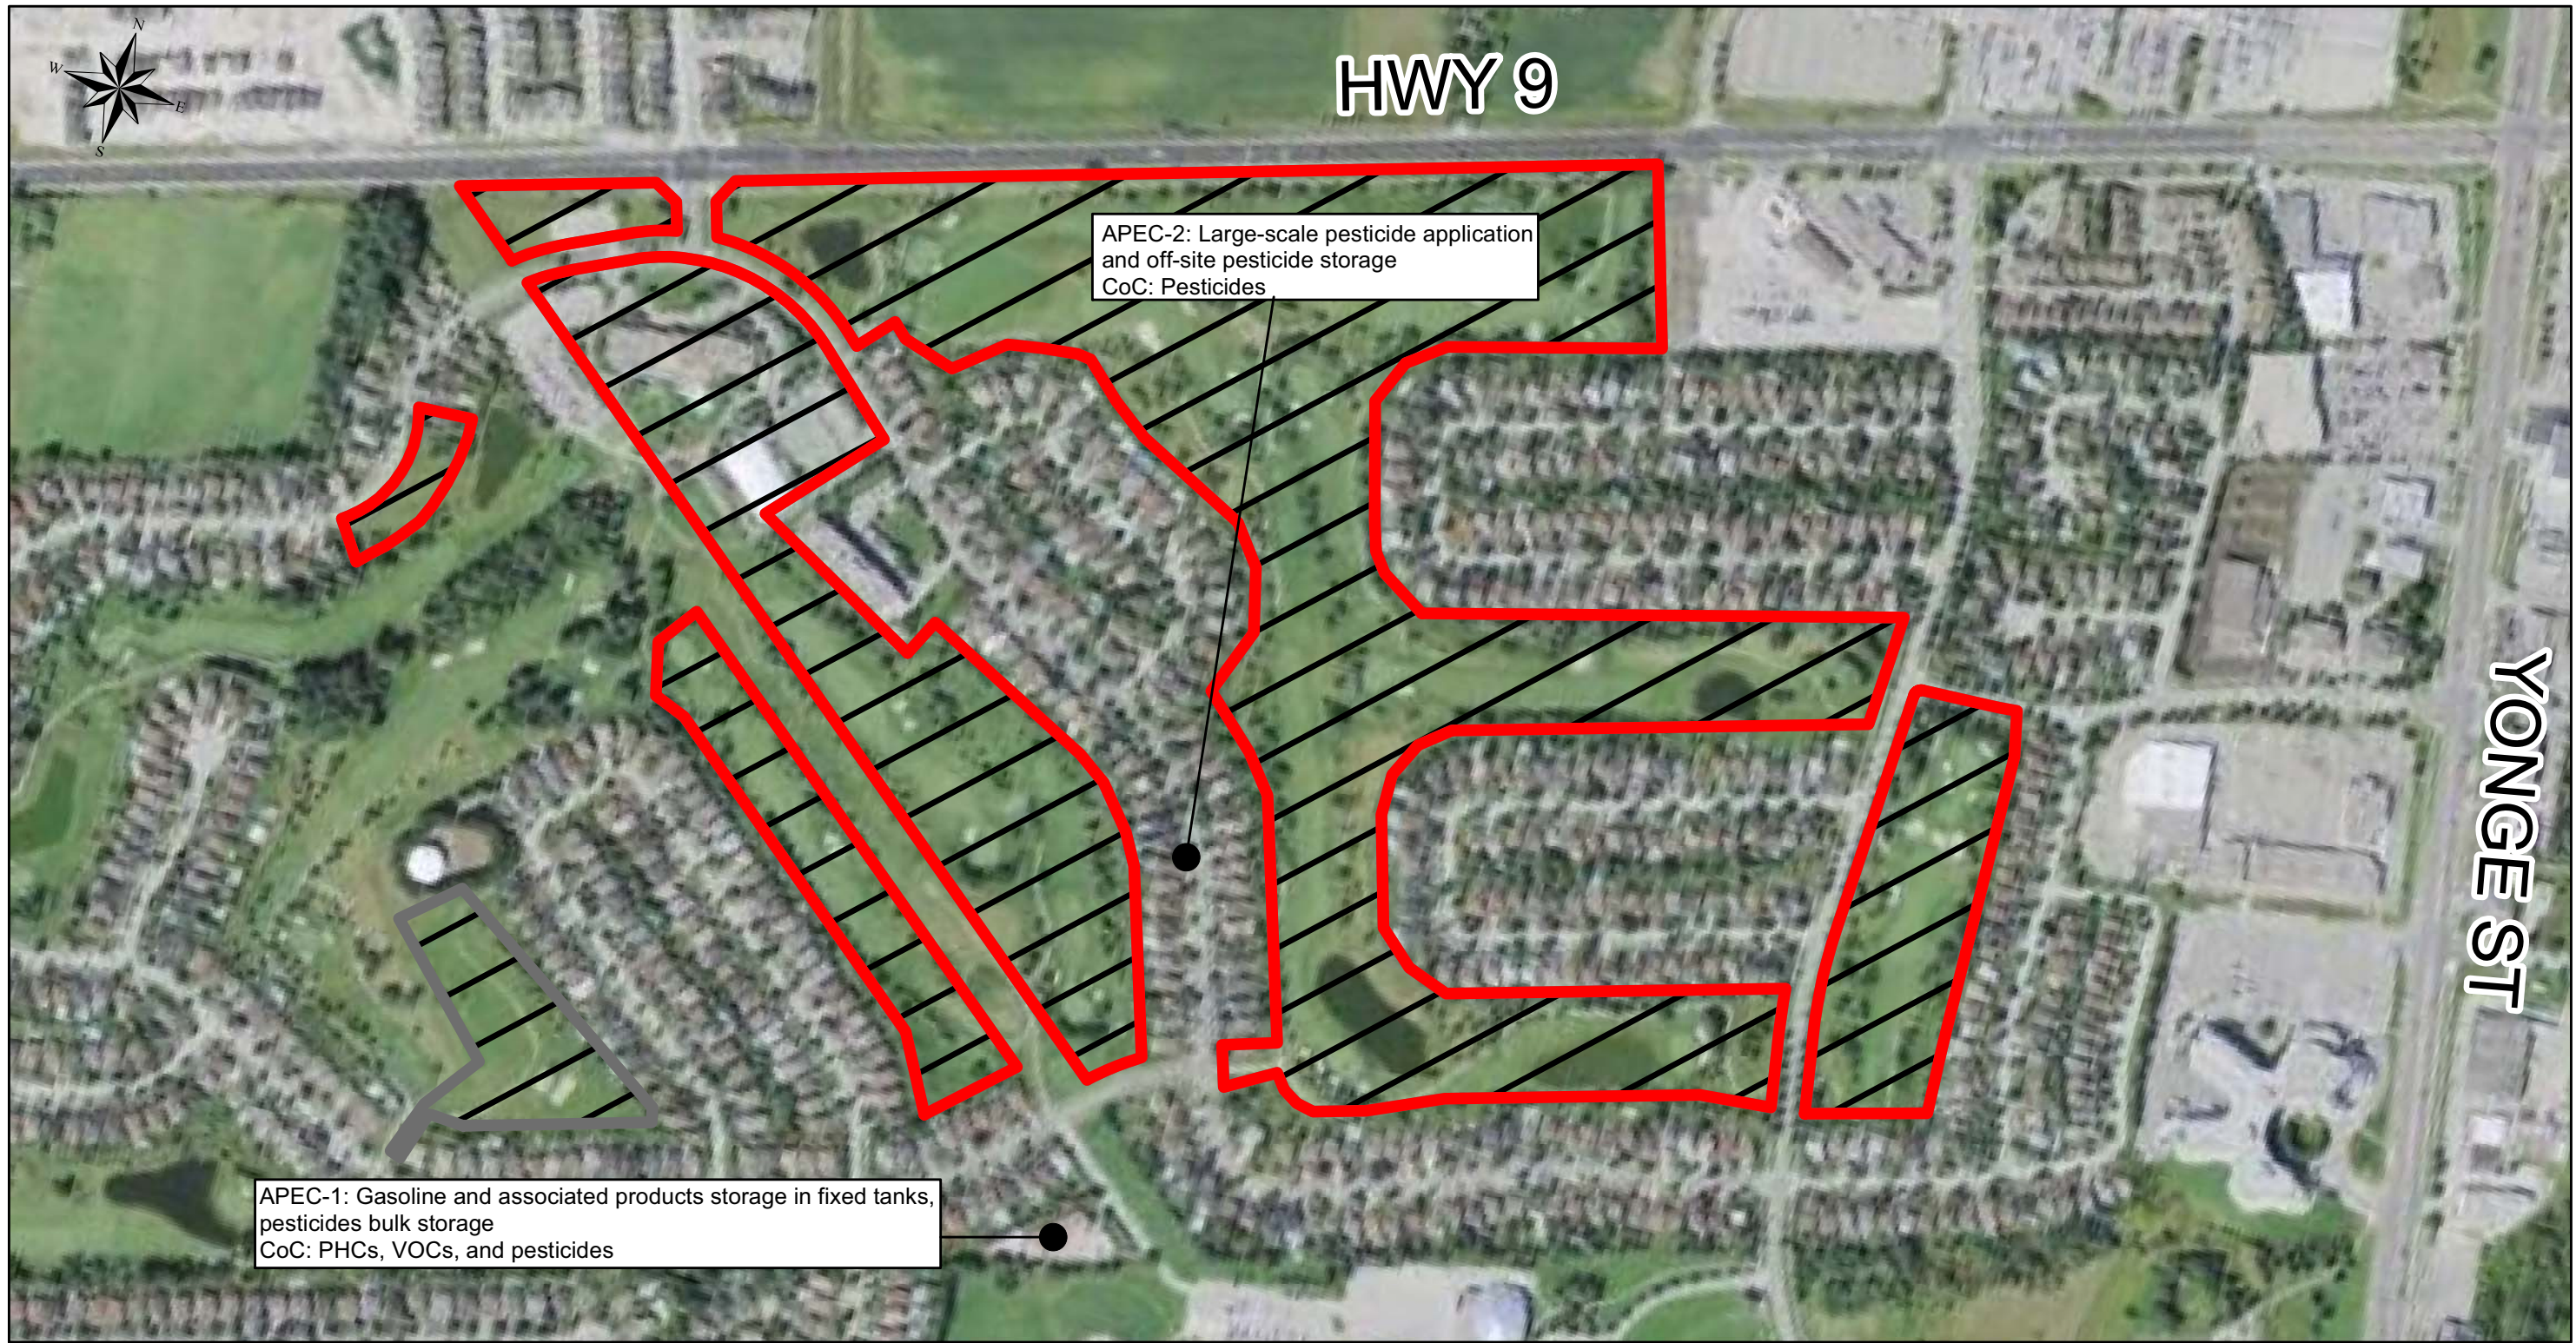
Figure No.  
**3**

The Site once contained a large building structure with no subsurface structure which would affect the migration of contaminants. This building has since been demolished and removed from the Site. **Figure 3** illustrates the building once observed on the Phase II ESA property. Underground utilities likely reside along Crossland Gate and may act to transport and distribute contaminants away from the Site.

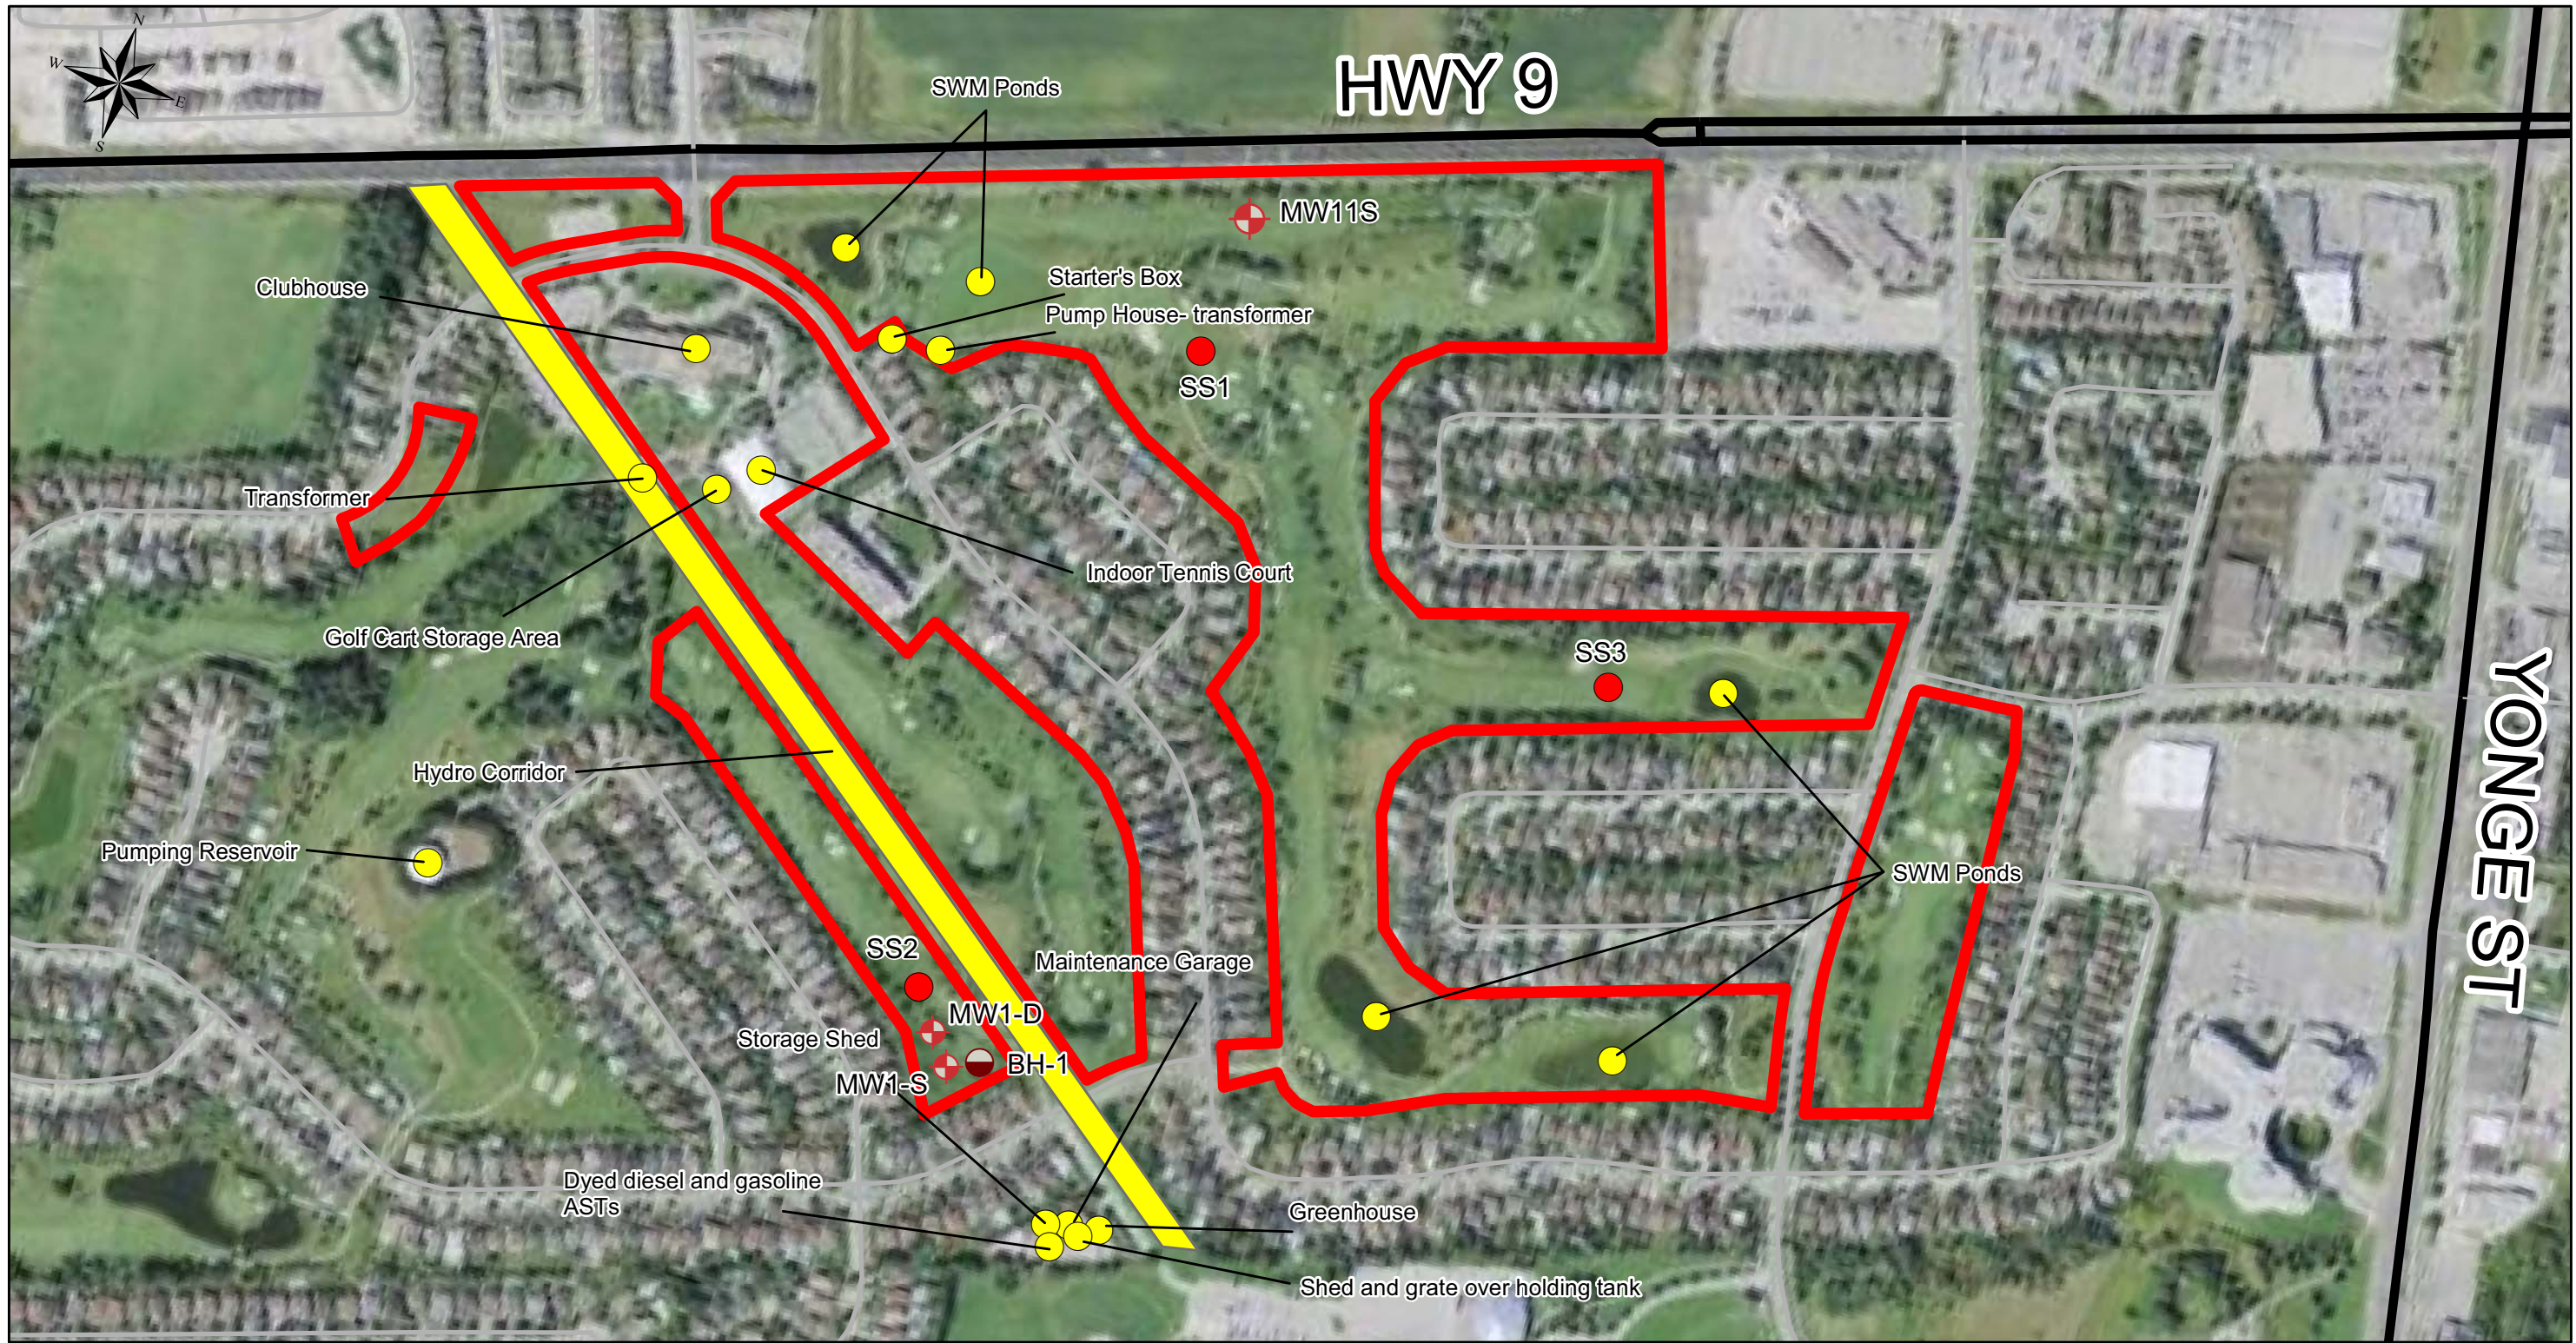
Project No: L09-301
	Drawn By: AC
Figure No. 4	Checked by: TL
	Date: March 2012

Borehole BH1 was drilled at the southern portion of the Site in the vicinity of MW1-S and MW1-D (**Figure 4**). The borehole was drilled to a depth of 3.05 mbg. The soil samples collected via split spoon at BH1 indicated a layer of moist, dark brown clayey silt to a depth of 0.30 mbg followed by a medium

**Site Plan**  
**Phase II Environmental Site Assessment**  
**Marianneville Development Limited**  
**470 Crossland Gate, Newmarket, ON**
